Manhole Inspection Summary

Manhole # S13W__002MH

Inspection ☐ Is Incomplete Rating: **3) Fair**

Location Address: **Wilso Dr.**

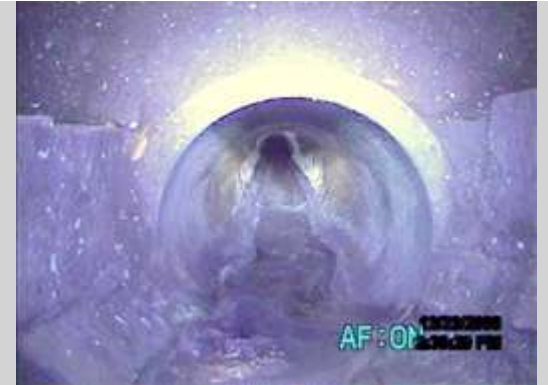
12 O'Clock Outflow

8 in. Circular Gravity Sewer
Pipe Out @ 12 O'Clock

Pipe Height: **8.4** (in.) Rod and Bar (Angled)
Pipe Material: **Clay** ☐ Pipe Lined
Invert Depth: **8.72** (ft.) Flow Characteristics: **Slow**
Deposits: ☒ None ☐ Mud ☐ Sludge ☐ Debris ☐ Grease
Silt Depth: **0** (in.) Deposits Extent:
Infiltration: **None** Pipe Seal Cond: **Sound**
